SAMPLE OF A "CONDITION CONCERN" PAGE:

Condition Concerns: *Recomend further review and correction as needed by competent professionals*

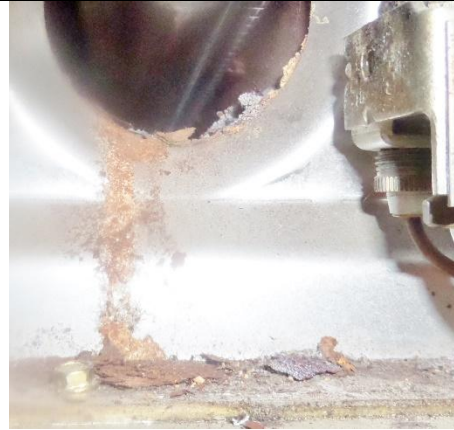
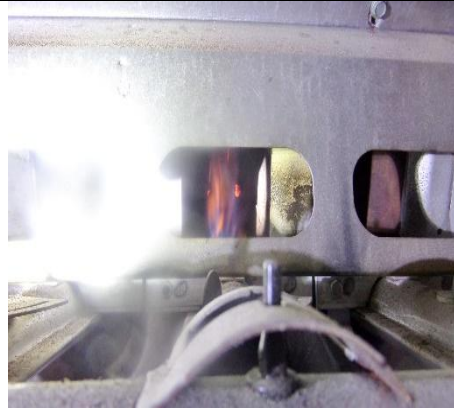
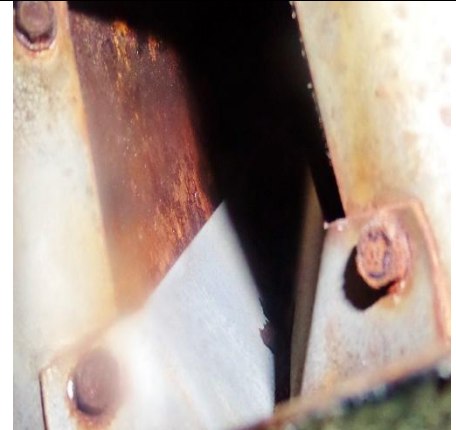
1- Upon observing the furnace it was noticed that much flaking, rusting of the metal heat exchanger sides and the presence of debris existed in the burn chamber. Additionally, the flame pattern was distorted on the burners. These are signs that the units heat exchanger is worn and a there is a concerning possibility that a depleted heat exchange exists. Once a furnaces heat exchanger develops cracks or holes it is no longer safe to use that furnace. It is strongly recommended that the furnace be cleaned and the components, namely the heat exchanger be inspected by a certified and licensed expert. Follow this experts recommendations and ask that professional to certify that the unit is capable of performing its duties in a safe manner.

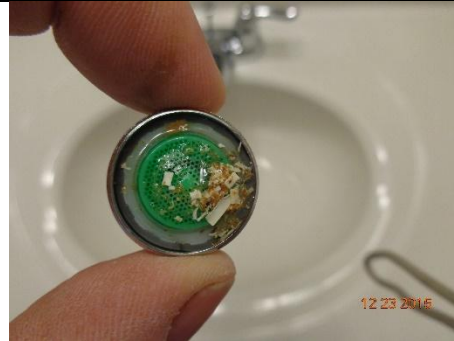
2- Have the spigot aerators cleaned of debris to assure good water flow at fixtures

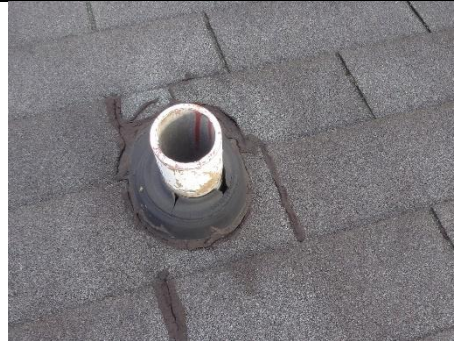
3- The rubber boots around vent pipe seals are in a depleted state and need attention from a roofer.

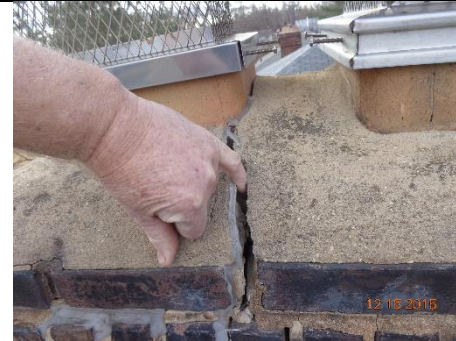
4- Consult a chimney mason to review the chase that serves the fireplace, the furnace and the water heater. Excessive cracking is present at the chimney's crown. Allow for extensive repairs!

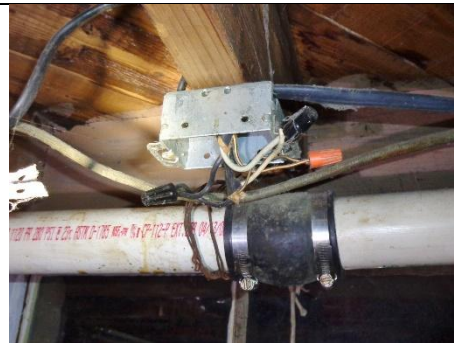
5- Hanging wires and exposed splices were discovered in the crawlspace sealing at three locations. Have a licensed electrician review all wiring in the crawlspace and effect corrections so that industry safe wiring practices will exist

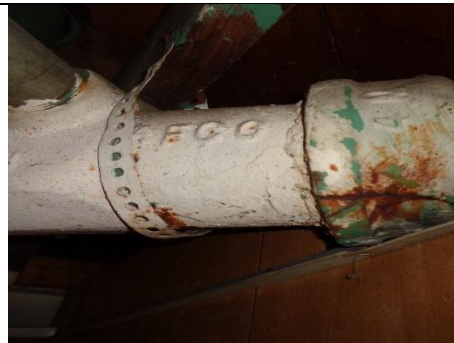
6- A sizable crack was discovered on the verticle drain pipe located in the basement ceiling. Have a plumber review and correct as needed.

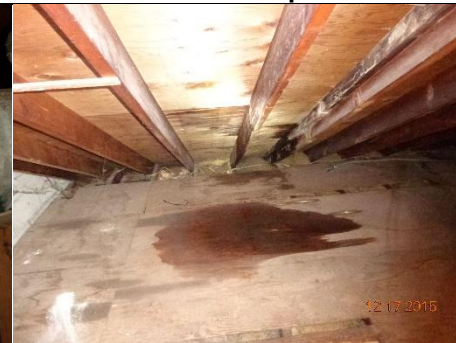
7- Active water leakage was observed in the attic area located above the garage. Have a roofer review and correct so that no further leaking will occur. The leaks appear to be generated from a satellite dish attached to the roof surface in this location.
